SAFETY RECALL

RZR

Communication #: Z-22-05

SUBJECT: PRIMARY CLUTCH FAILURE PURPOSE

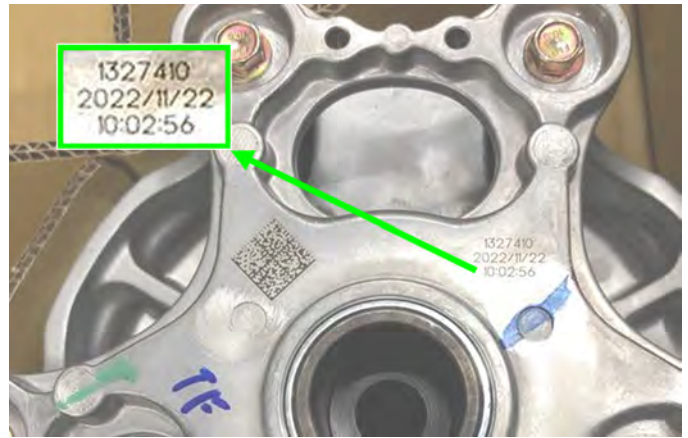
Record the manufacturing information numbers on the *NEW* primary clutch for warranty claims processing. Claims filing will not be permitted without the *NEW* primary clutch manufacturing information numbers.

Clutch Part Number ①: _____
 Clutch Production Date ②: _____
 Clutch Production Time ③: _____

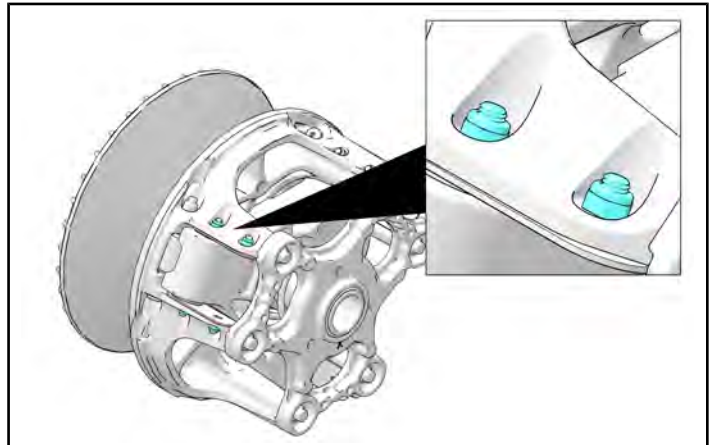
NEW CLUTCH

MODEL	NEW PART NUMBER (PN)
RZR TURBO S	1327410
RZR TURBO S 4	
RZR XP TURBO	
RZR XP 4 TURBO

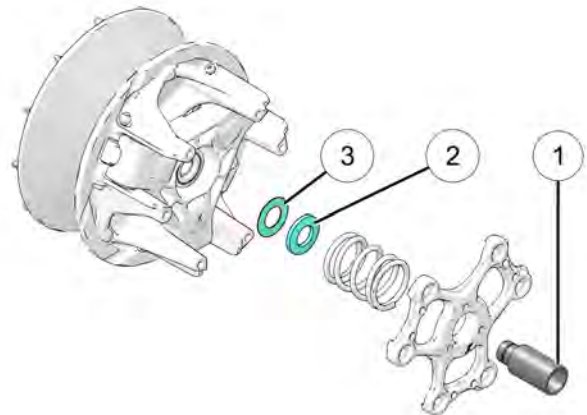
When the outer slip-fit post ① is removed, the belleville washer ② and flat washer ③ will fall out of the clutch assembly. **DISCARD** the slip-fit post and washers. These will be pre-installed in the **NEW** clutch assembly.

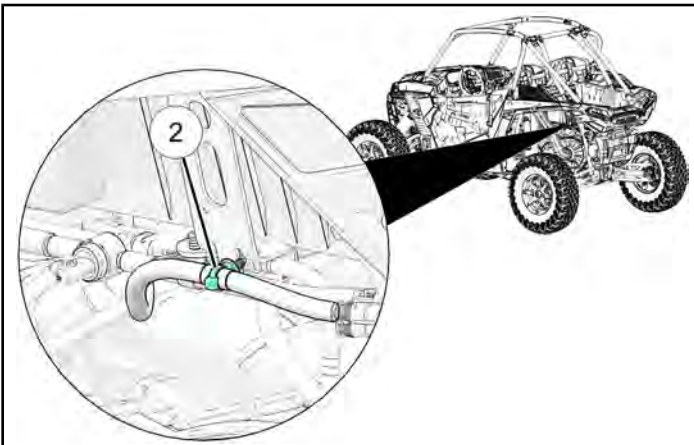
10. Disconnect the fir tree clip ② on the box harness from the box support.

If the fir tree clip is damaged during removal, a replacement clip is provided in the kit.

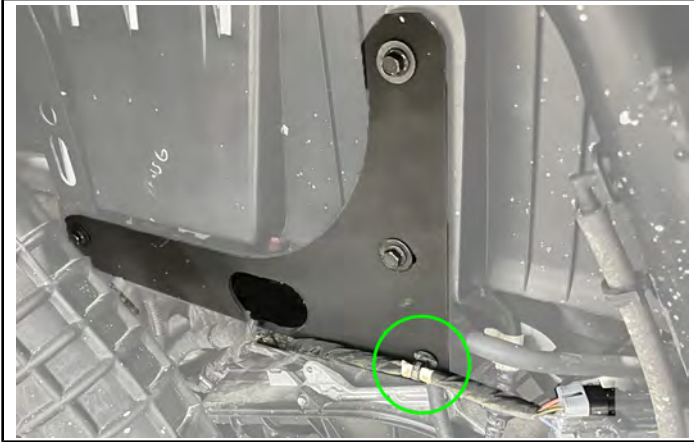
15. Attach the box harness to the fuel line bracket. If the fir tree clip has been damaged, a replacement is provided in the kit.

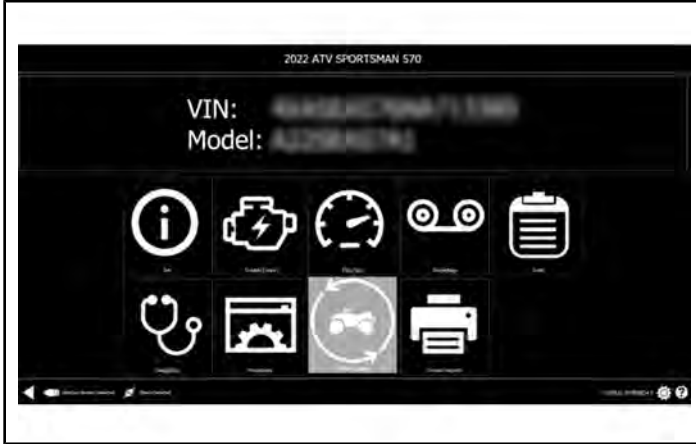
1. Connect the vehicle to Digital Wrench. Refer to the Digital Wrench II User Manual for information on connecting Digital Wrench II. Go to DEX > Service and Warranty > STOP Site > Other Publications > DWII User Manual.
2. Click the **Vehicle Update** button.

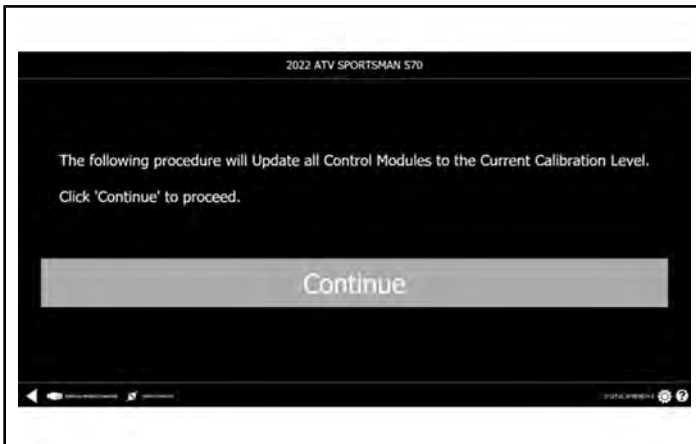
3. Click the **Continue** button. Digital Wrench will gather data from the vehicle modules.

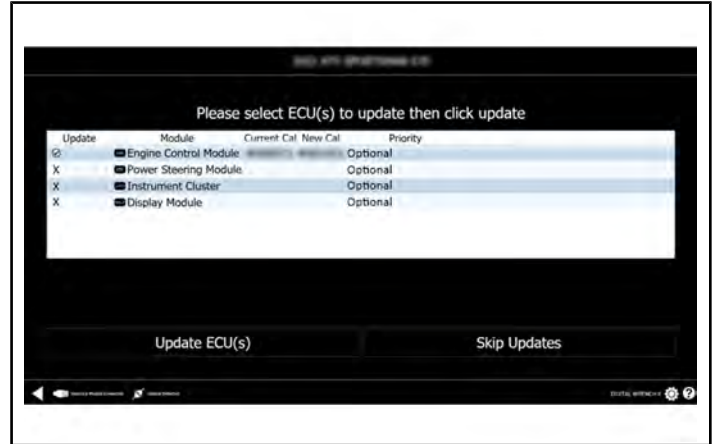
4. Select the Engine Control Module and any other modules with an update available, and click **Update ECU(s)**.

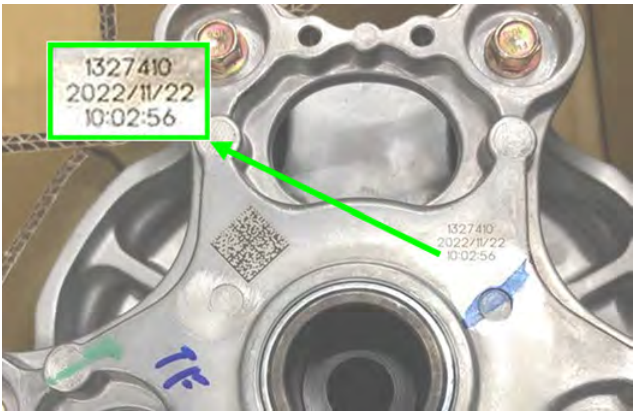
Clutch Part Number ①: _____

Clutch Production Date ②: _____

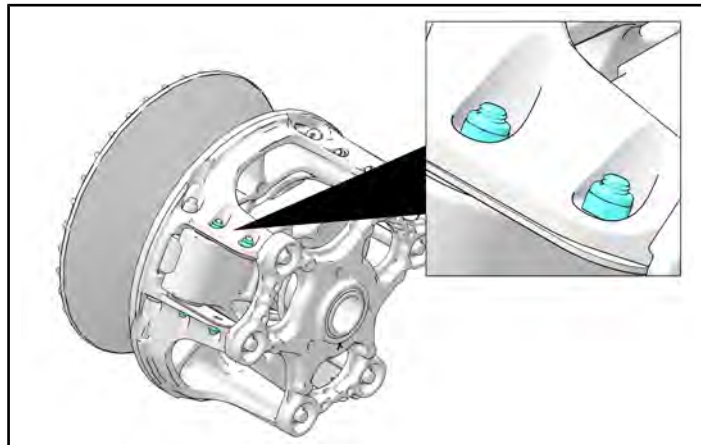
NEW CLUTCH

MODEL	NEW PART NUMBER (PN)
RZR TURBO S	1327410
RZR TURBO S 4	
RZR XP TURBO	
RZR XP 4 TURBO

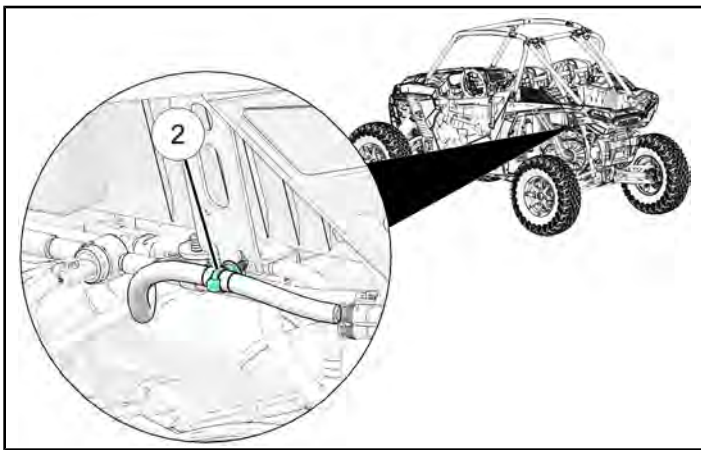
If the fir tree clip is damaged during removal, a replacement clip is provided in the kit.

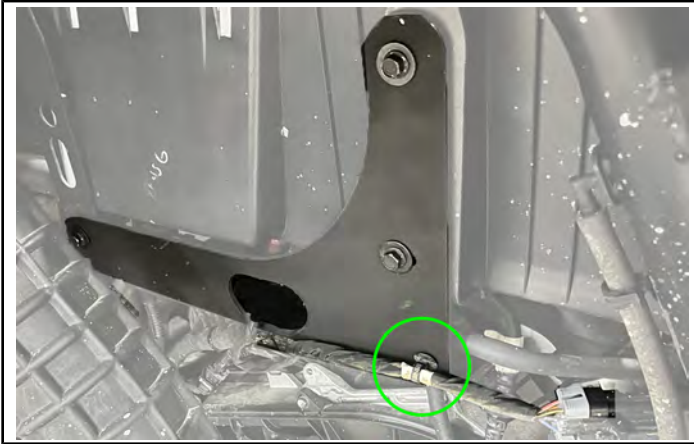
15. Attach the box harness to the fuel line bracket. If the fir tree clip has been damaged, a replacement is provided in the kit.

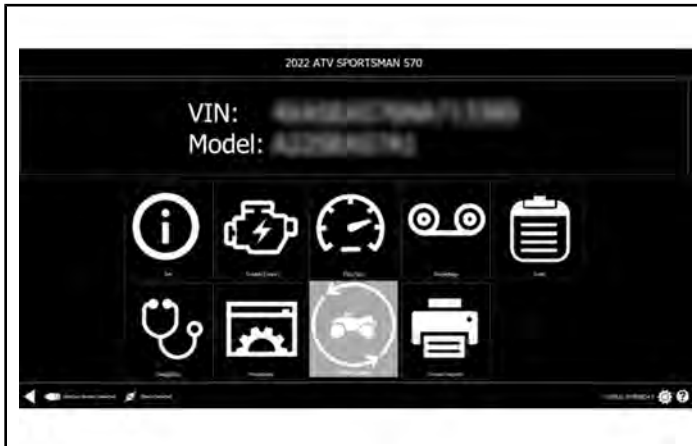
1. Connect the vehicle to Digital Wrench. Refer to the Digital Wrench II User Manual for information on connecting Digital Wrench II. Go to DEX > Service and Warranty > STOP Site > Other Publications > DWII User Manual.
2. Click the **Vehicle Update** button.

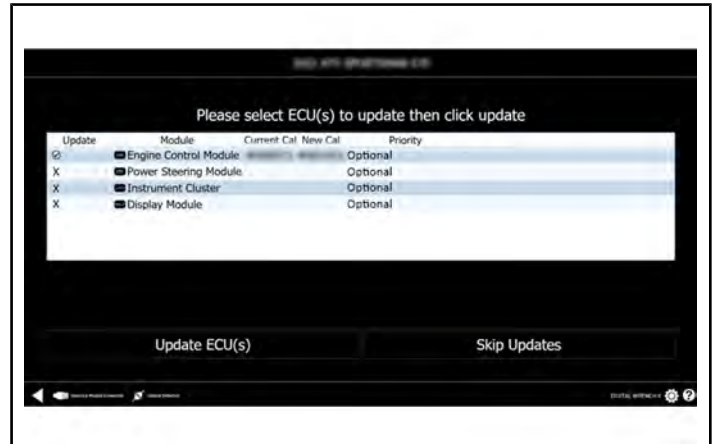
4. Select the Engine Control Module and any other modules with an update available, and click **Update ECU(s)**.
