SAFETY RECALL

RZR

Communication #: Z-22-05

SUBJECT: PRIMARY CLUTCH FAILURE PURPOSE

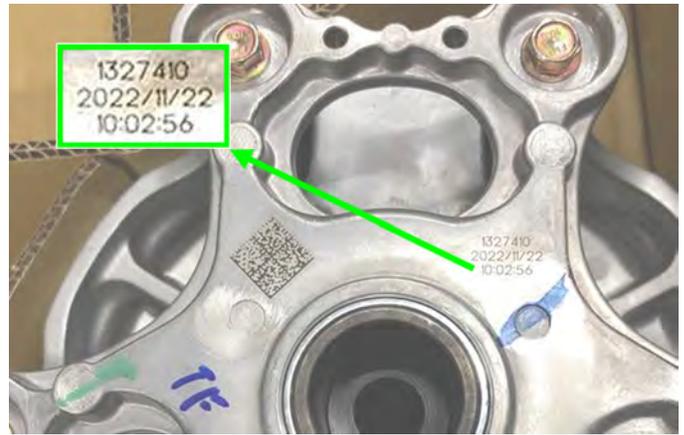
Record the manufacturing information numbers on the *NEW* primary clutch for warranty claims processing. Claims filing will not be permitted without the *NEW* primary clutch manufacturing information numbers.

Clutch Part Number ①: _____
 Clutch Production Date ②: _____
 Clutch Production Time ③: _____

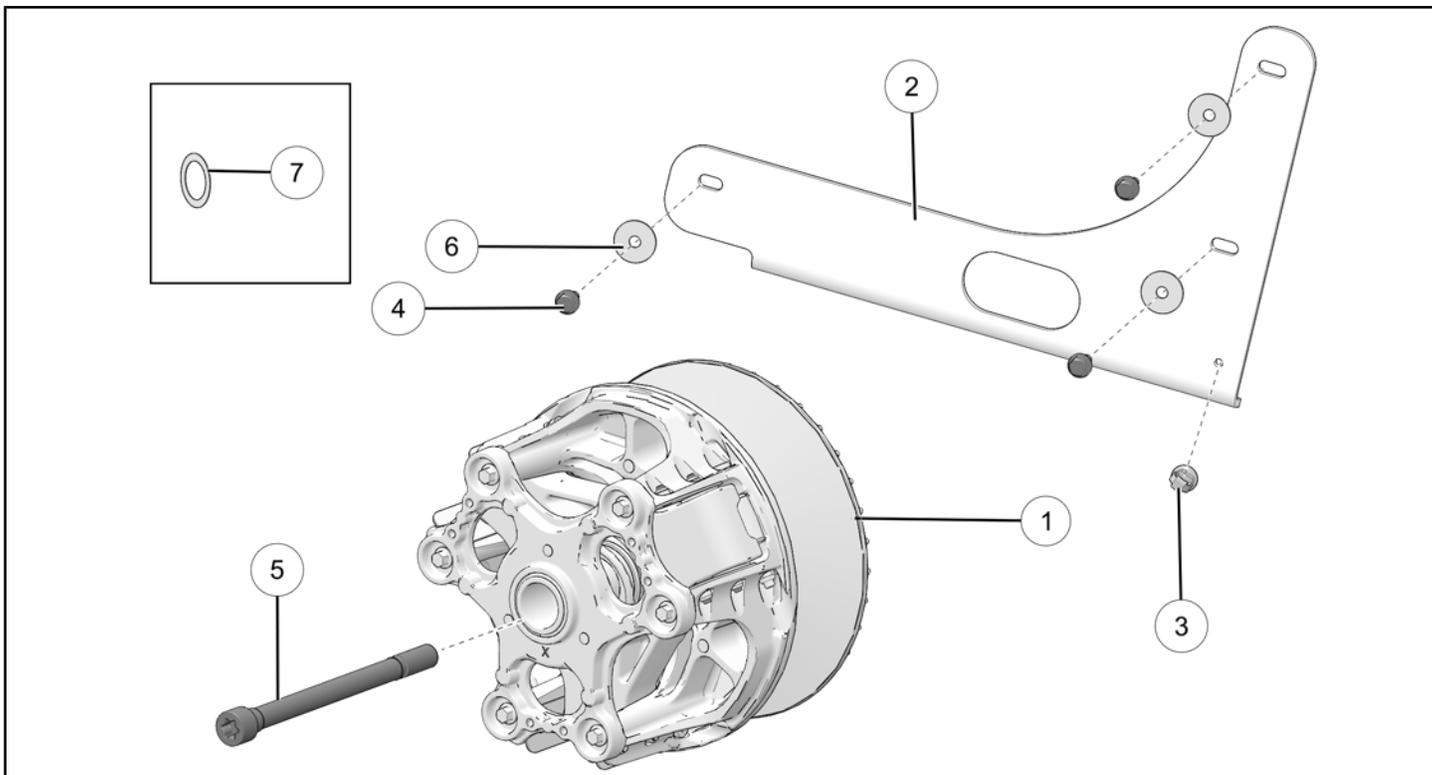
2211626 K-CLUTCH,TURBO-S,CHAMP,MY21

REFER- ENCE	QTY	PART DESCRIPTION	P/N AVAILABLE SEPARATELY
①	1	ASM-DRIVE CLUTCH,31MM	1327410
②	1	BRKT-GUARD,CLUTCH	5274390
③	1	CLIP-ROUTING	7082068
④	3	SCR-M6X1.0X20,HXHD,FLG,TDFM,BK	7518529
⑤	1	SCR-HXFL,M14X1.5X180 12.9 SPC	7520950
⑥	3	WASHER-.281X1.00X.051	7556329
⑦	5	SHIM-RING,23.25X32.25X0.5 <i>Shims are provided in the kit to allow for proper clutch alignment. Shims install to the secondary clutch. 5 shims are included, but up to 8 total may be used if additional adjustment is necessary.</i>	7557060

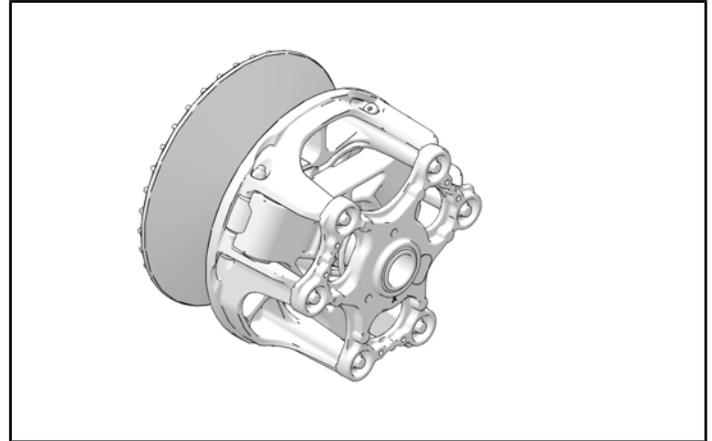
OLD CLUTCH

Ensure that the correct clutch is installed. Installing the incorrect clutch can result in a vehicle hazard. Review the following images and table to ensure that the correct clutch is installed on the affected vehicle.

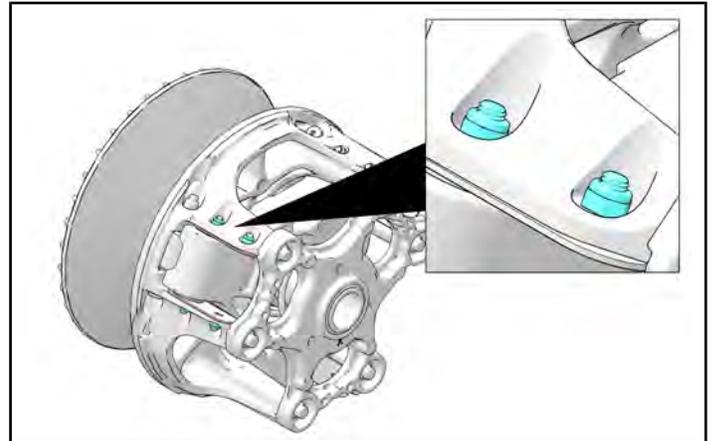
NEW CLUTCH

MODEL	NEW PART NUMBER (PN)
RZR TURBO S	1327410
RZR TURBO S 4	
RZR XP TURBO	
RZR XP 4 TURBO

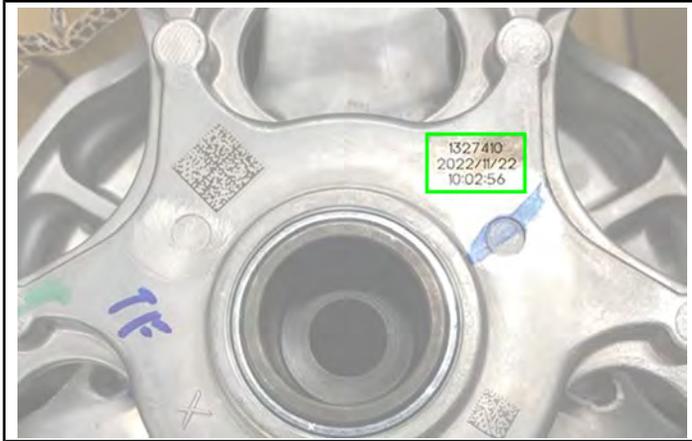
Reference the image below for the location of the part number on the *NEW* clutch.

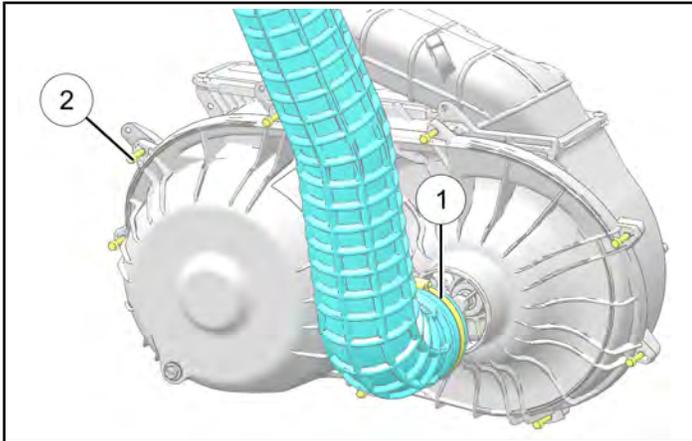
1. Loosen the clamp ① retaining PVT inlet duct to the outer clutch cover.
2. Loosen the fasteners ② that retain the outer clutch cover. Remove the clutch cover.

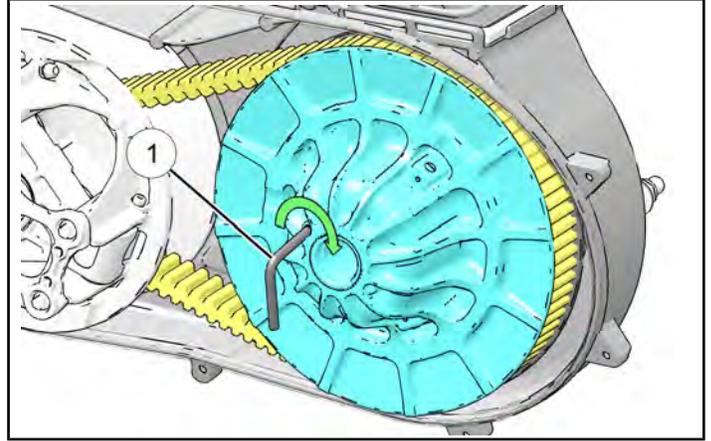
Clutch Spreader Tool:
2883577

4. Insert clutch spreader tool into the driven clutch and turn the tool clockwise to open the sheaves on the driven clutch.

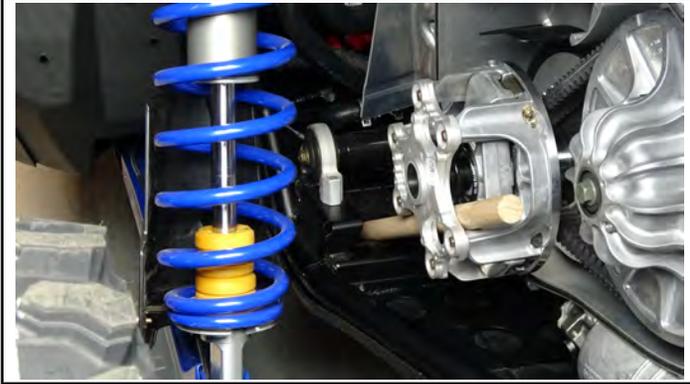
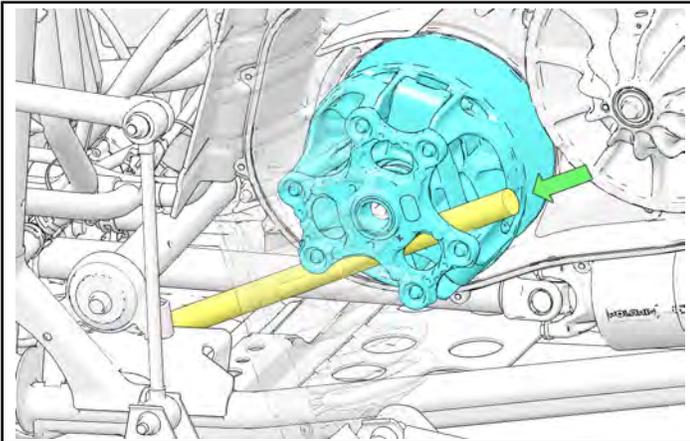
Dowel Use: using a 1" diameter by 18" long hardwood dowel insert the dowel through the drive clutch allowing it to rest against the chassis underneath the front engine cross member as shown.

The dowel must NOT touch the machined tower surface of the drive clutch, damage to the drive clutch may result.

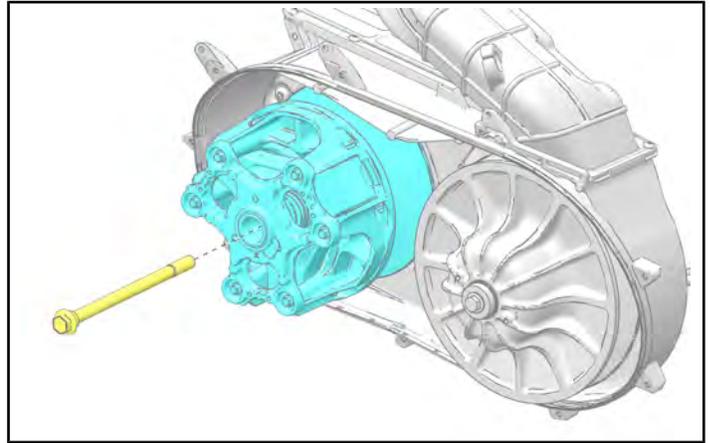
7. Remove the drive clutch retaining bolt using a T-60 Torx internal driver and DISCARD.

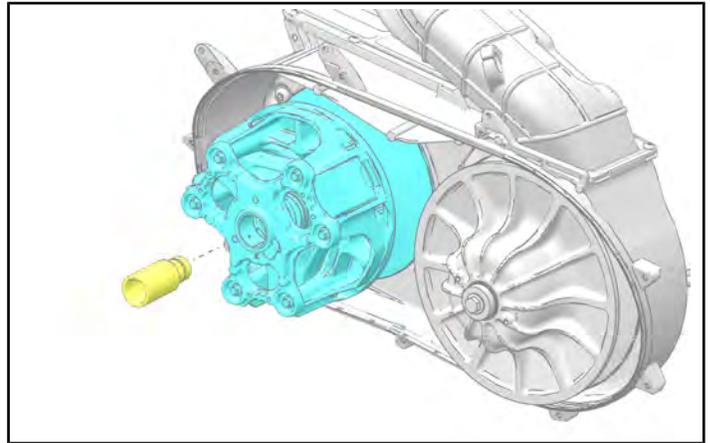
8. Remove the outer slip fit post.

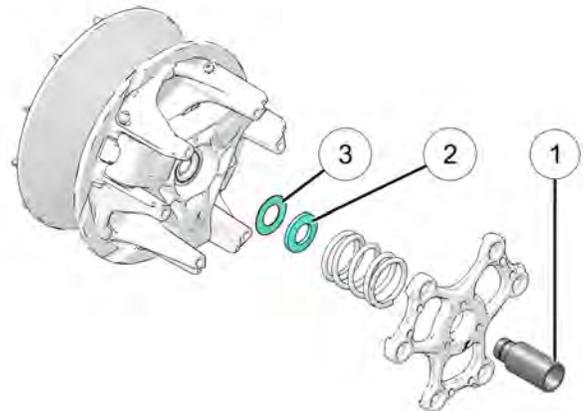
When the outer slip-fit post ① is removed, the belleville washer ② and flat washer ③ will fall out of the clutch assembly. **DISCARD** the slip-fit post and washers. These will be pre-installed in the **NEW** clutch assembly.

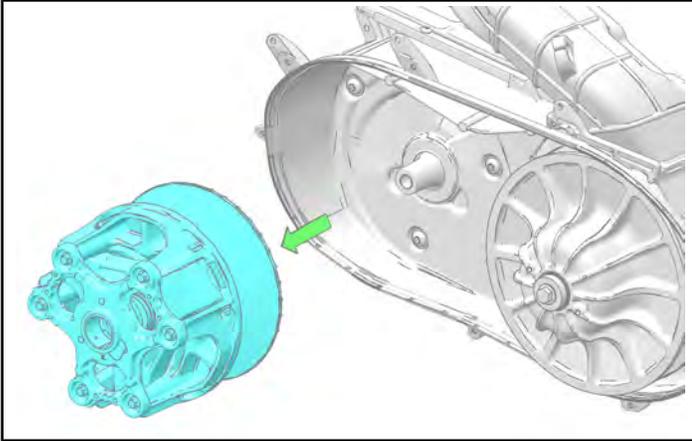
9. Using Drive Clutch Puller (PN **PU-52422**), remove the primary clutch assembly.

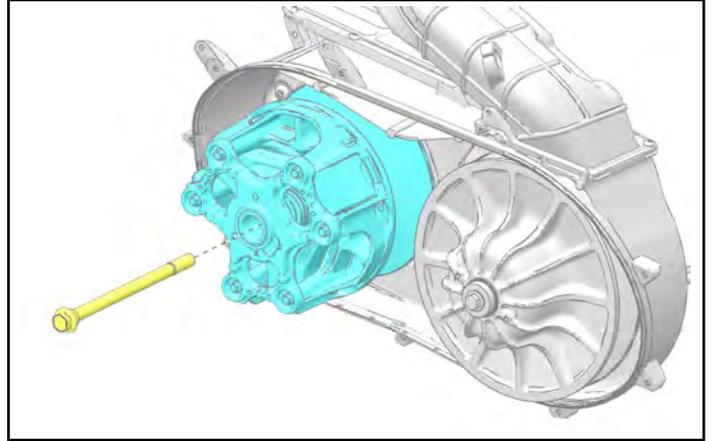
1. Clean the crankshaft taper using isopropyl alcohol or an equivalent. Allow to dry prior to installation.
2. Install the *NEW* primary (drive) clutch assembly and *NEW* primary clutch bolt.

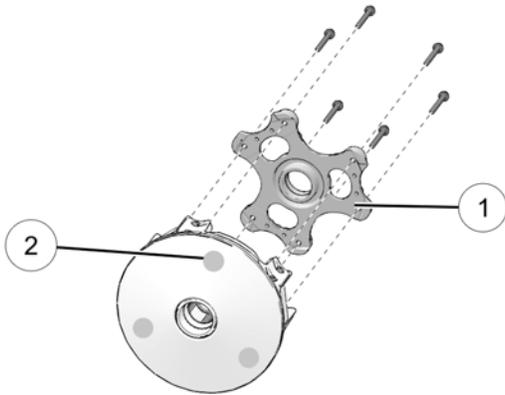
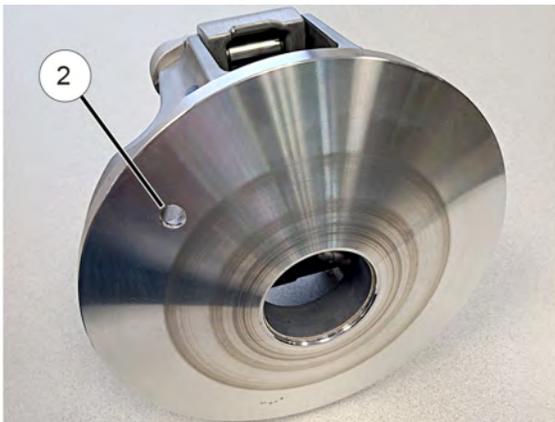
1. Return the primary clutch spider cover ① to Polaris via warranty parts return.
2. Render the remaining primary clutch assembly unusable by drilling a hole ② in the moveable sheave. Discard the clutch. The following image shows possible drill hole ② locations.

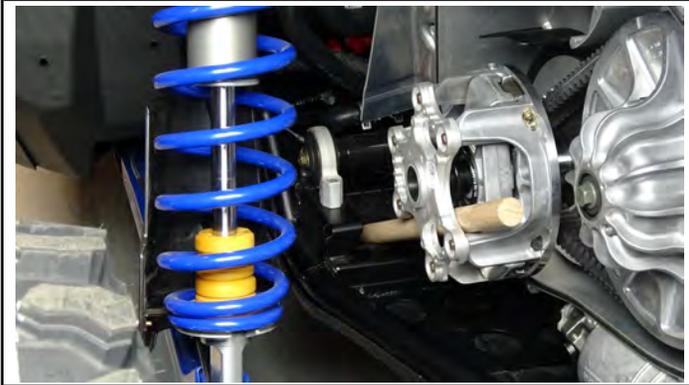
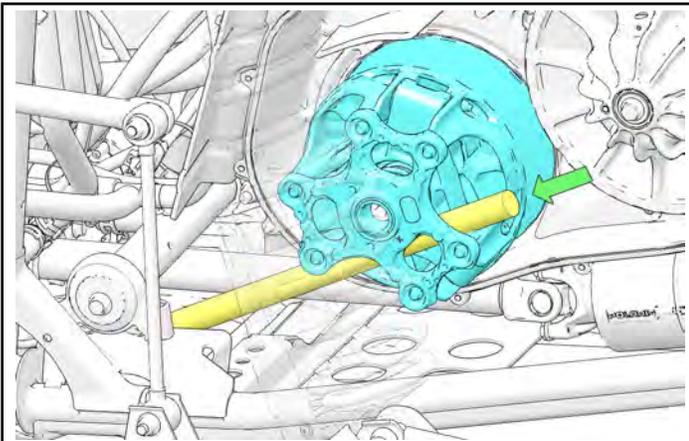
Dowel Use: using a 1" diameter by 18" long hardwood dowel insert the dowel through the primary clutch allowing it to rest against the chassis underneath the front engine cross member as shown.

The dowel must NOT touch the machined tower surface of the primary clutch, damage to the primary clutch may result.

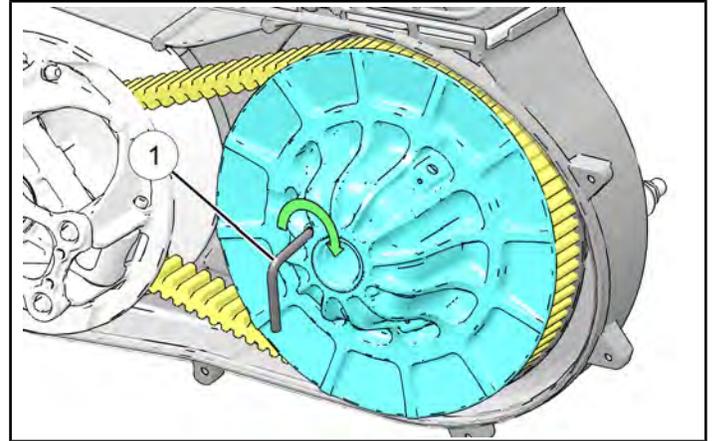
Clutch Spreader Tool:
2883577

5. With the clutch spreader tool ① installed, loop the belt over the primary clutch and over the driven clutch. Verify correct belt orientation.

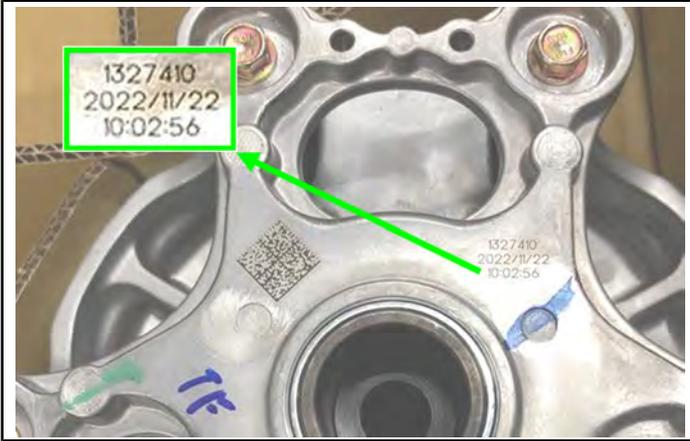
Record the manufacturing information numbers on the *NEW* primary clutch for warranty claims processing. Claims filing will not be permitted without the *NEW* primary clutch manufacturing information numbers.

Clutch Part Number: _____
 Clutch Production Date: _____
 Clutch Production Time: _____

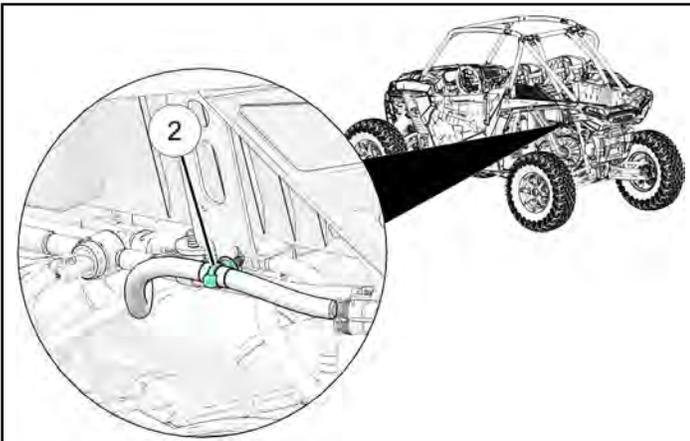
10. Disconnect the fir tree clip ② on the box harness from the box support.

If the fir tree clip is damaged during removal, a replacement clip is provided in the kit.

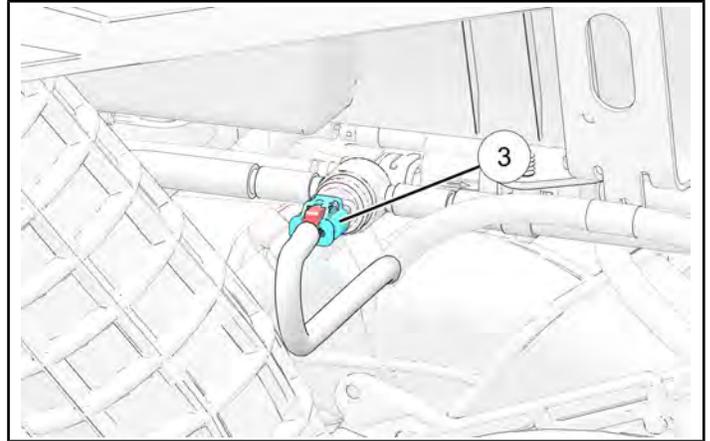
11. Release the secondary retaining clip ③ on the fuel pressure sensor using a screwdriver or pick. Push down on the connector tab to release the connector.

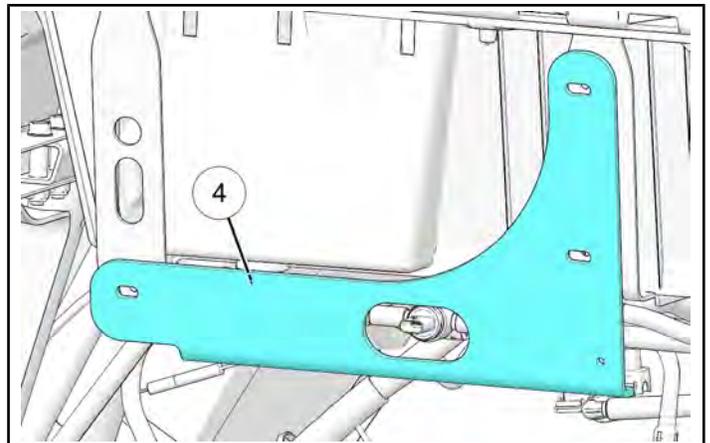
12. Set the fuel line bracket ④ into place.

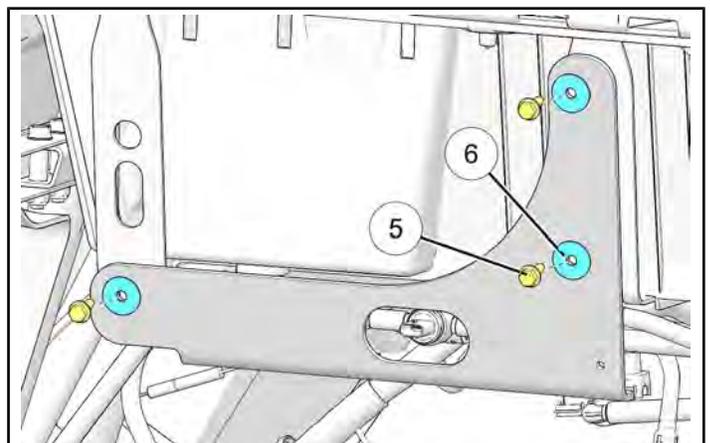
13. Loosely install the three fasteners ⑤ and washers ⑥ into the box support, two in the rear box support and one in the front box support.

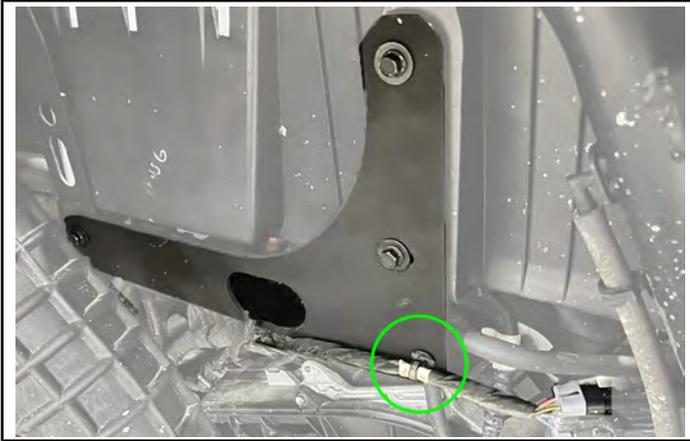
15. Attach the box harness to the fuel line bracket. If the fir tree clip has been damaged, a replacement is provided in the kit.

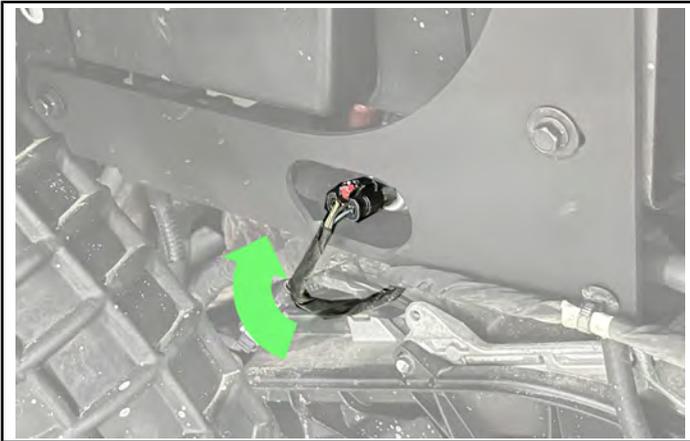
16. Route the fuel pressure sensor harness underneath and back through the hole in the bracket. Connect it to the sensor until a click is heard, and engage the red secondary retaining tab by pushing it towards the sensor.

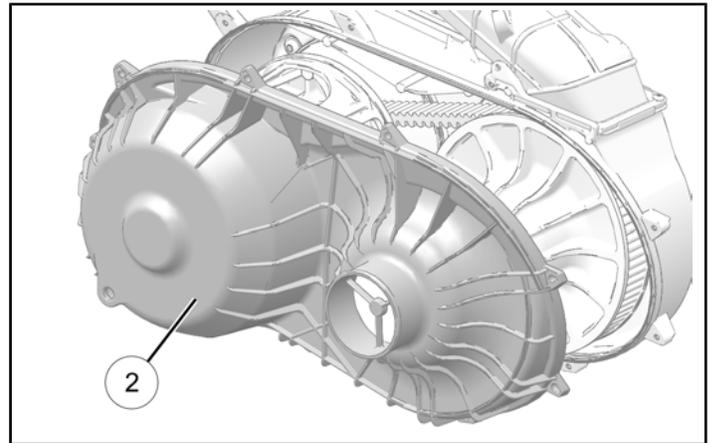
17. Install the outer PVT cover ②.

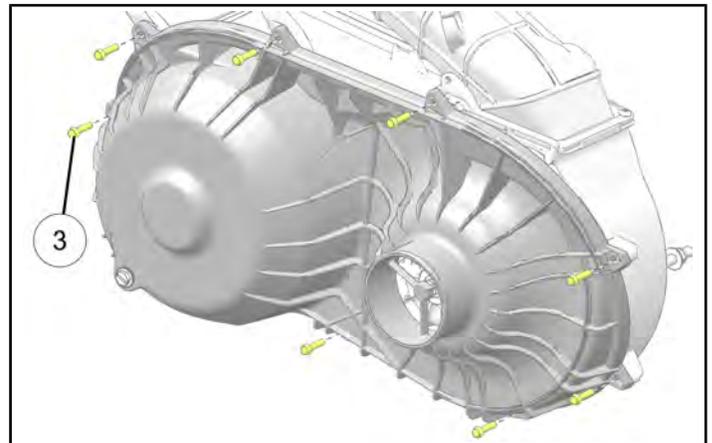
18. Install the outer cover fasteners ③. Torque to specification.

**Outer Clutch Cover Fasteners:
36 in-lbs (4 Nm)**

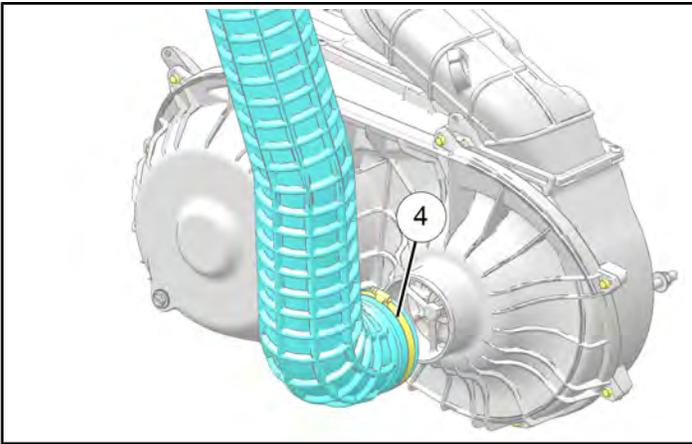
19. Install the PVT inlet duct to the outer clutch cover.
Torque the clamp ④ retaining the duct to the cover.

PVT Intake Hose Clamp:
25 in-lbs (3 Nm)

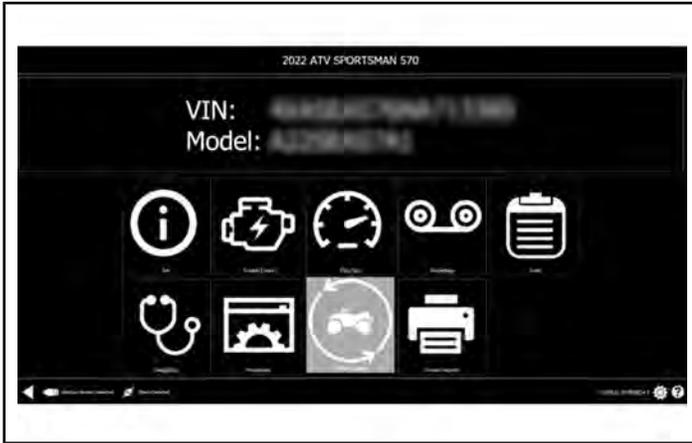
1. Connect the vehicle to Digital Wrench. Refer to the Digital Wrench II User Manual for information on connecting Digital Wrench II. Go to DEX > Service and Warranty > STOP Site > Other Publications > DWII User Manual.
2. Click the **Vehicle Update** button.

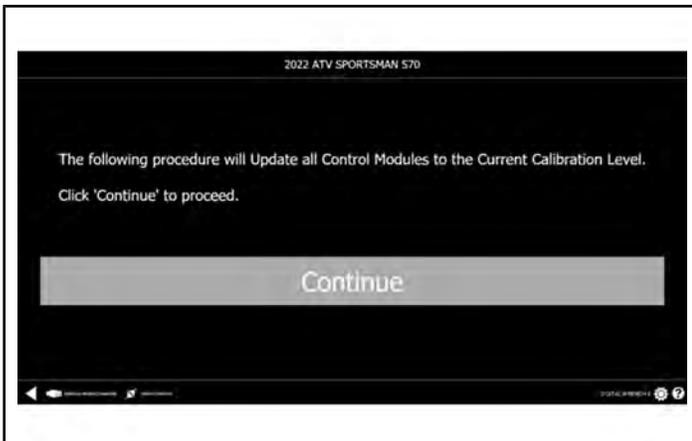
3. Click the **Continue** button. Digital Wrench will gather data from the vehicle modules.

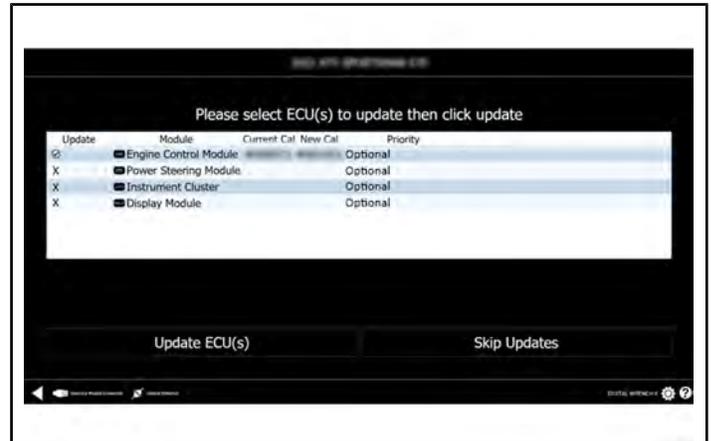
4. Select the Engine Control Module and any other modules with an update available, and click **Update ECU(s)**.

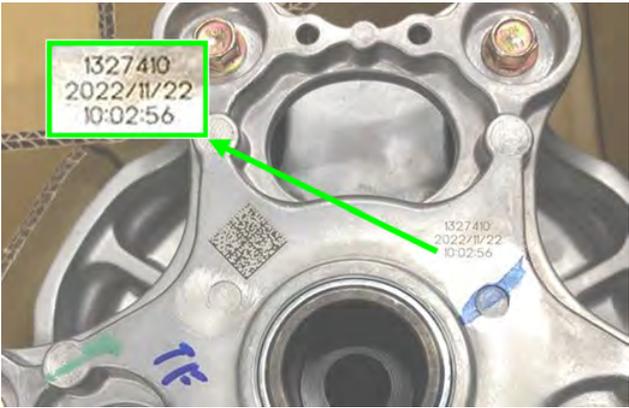
Clutch Part Number ①: _____

Clutch Production Date ②: _____

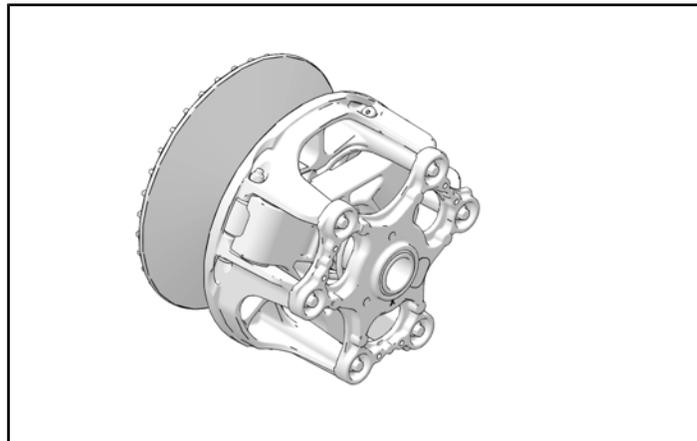
OLD CLUTCH

Ensure that the correct clutch is installed. Installing the incorrect clutch can result in a vehicle hazard. Review the following images and table to ensure that the correct clutch is installed on the affected vehicle.

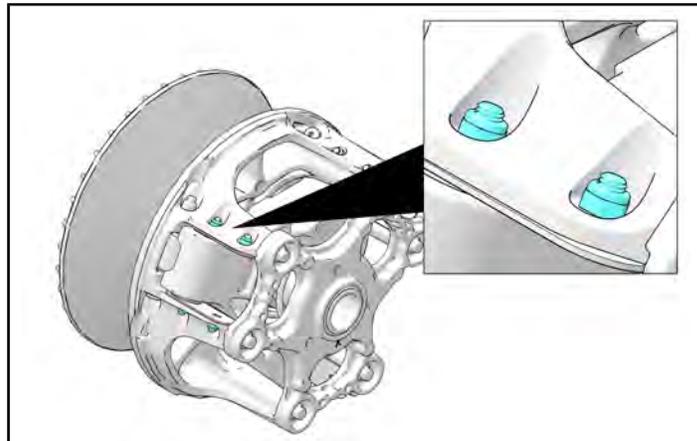
NEW CLUTCH

MODEL	NEW PART NUMBER (PN)
RZR TURBO S	1327410
RZR TURBO S 4	
RZR XP TURBO	
RZR XP 4 TURBO

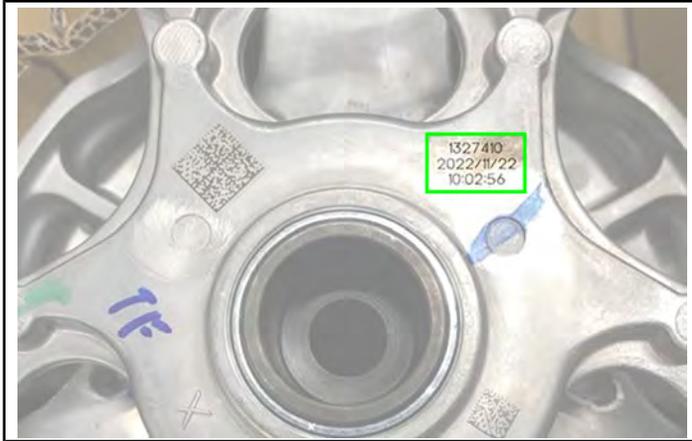
Reference the image below for the location of the part number on the *NEW* clutch.

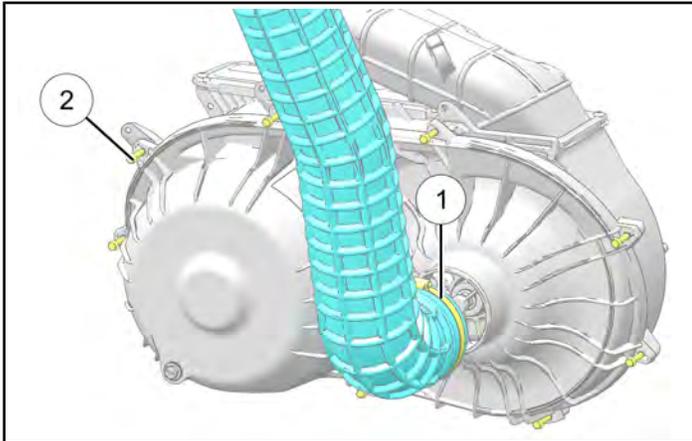
1. Loosen the clamp ① retaining PVT inlet duct to the outer clutch cover.
2. Loosen the fasteners ② that retain the outer clutch cover. Remove the clutch cover.

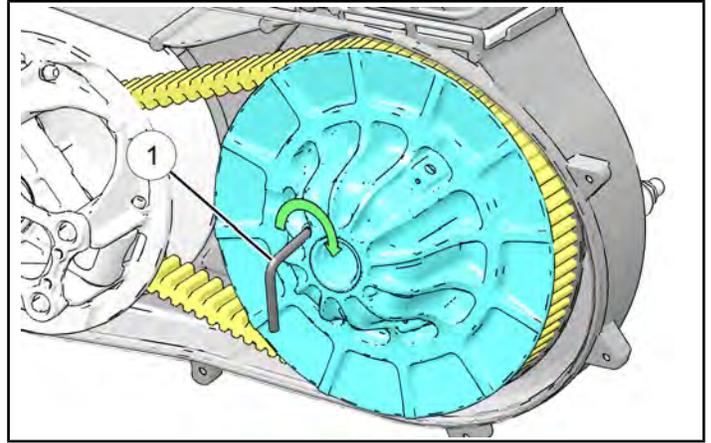
Clutch Spreader Tool:
2883577

4. Insert clutch spreader tool into the driven clutch and turn the tool clockwise to open the sheaves on the driven clutch.

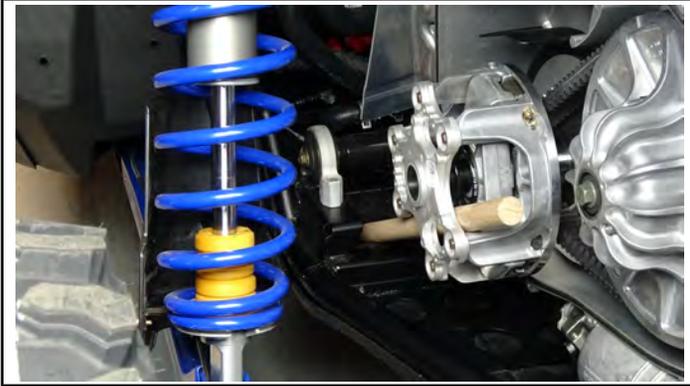
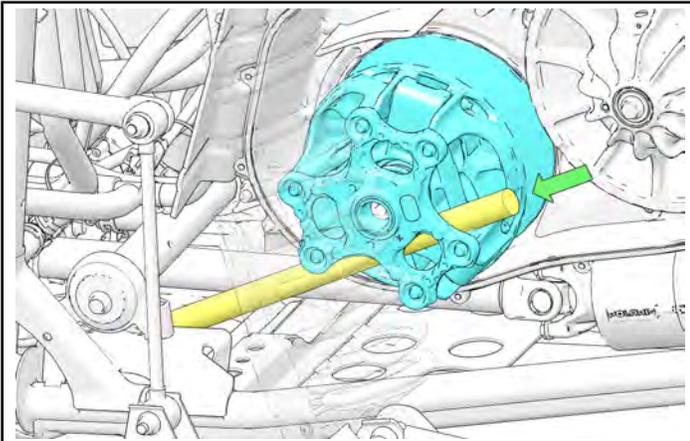
Dowel Use: using a 1" diameter by 18" long hardwood dowel insert the dowel through the drive clutch allowing it to rest against the chassis underneath the front engine cross member as shown.

The dowel must **NOT** touch the machined tower surface of the drive clutch, damage to the drive clutch may result.

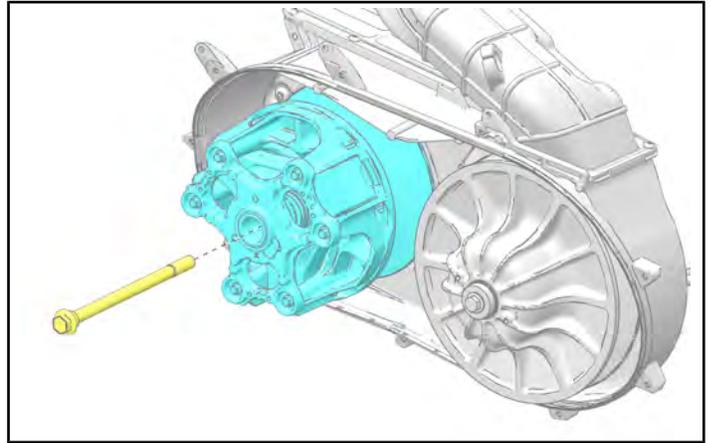
7. Remove the drive clutch retaining bolt using a T-60 Torx internal driver and **DISCARD**.

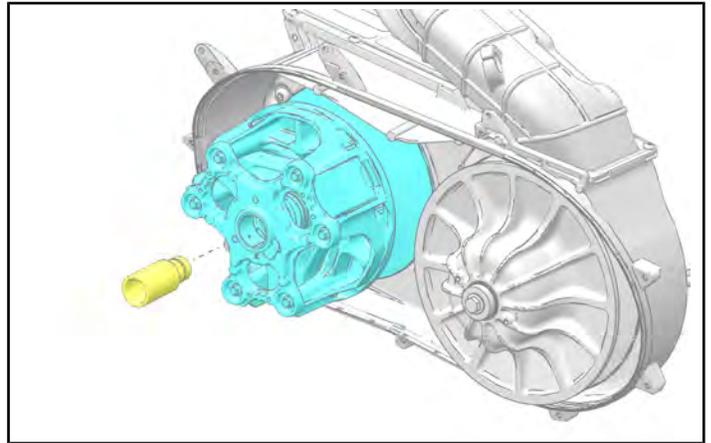
8. Remove the outer slip fit post.

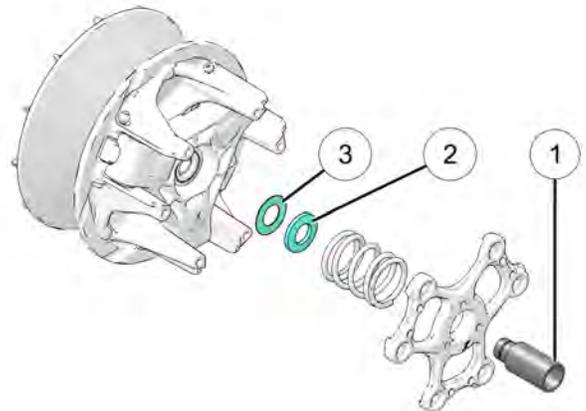
When the outer slip-fit post ① is removed, the Belleville washer ② and flat washer ③ will fall out of the clutch assembly. **DISCARD** the slip-fit post and washers. These will be pre-installed in the **NEW** clutch assembly.

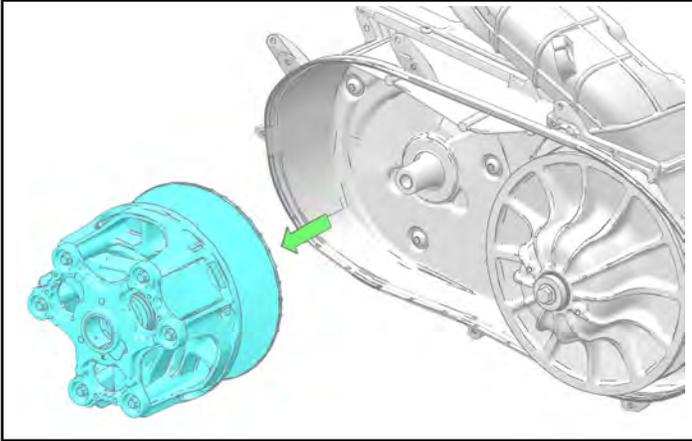
9. Using Drive Clutch Puller (PN **PU-52422**), remove the primary clutch assembly.

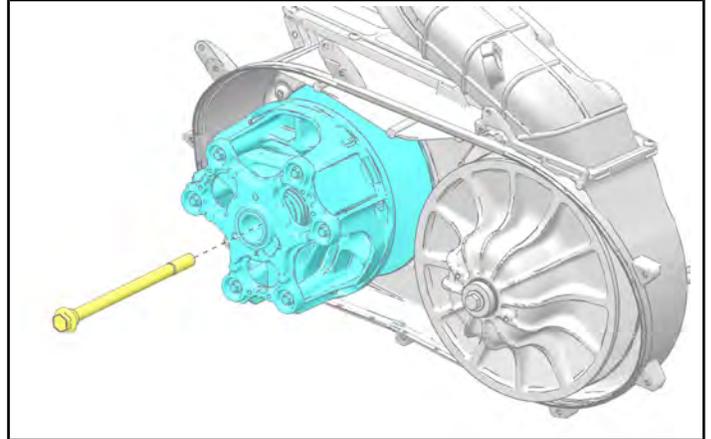
1. Clean the crankshaft taper using isopropyl alcohol or an equivalent. Allow to dry prior to installation.
2. Install the *NEW* primary (drive) clutch assembly and *NEW* primary clutch bolt.

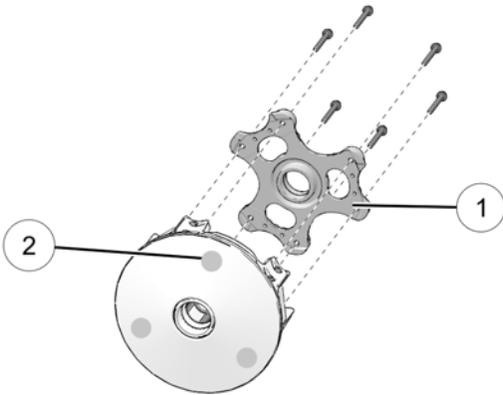
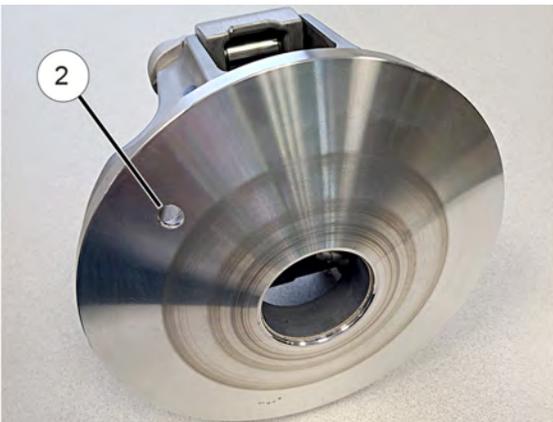
1. Return the primary clutch spider cover ① to Polaris via warranty parts return.
2. Render the remaining primary clutch assembly unusable by drilling a hole ② in the moveable sheave. Discard the clutch. The following image shows possible drill hole ② locations.

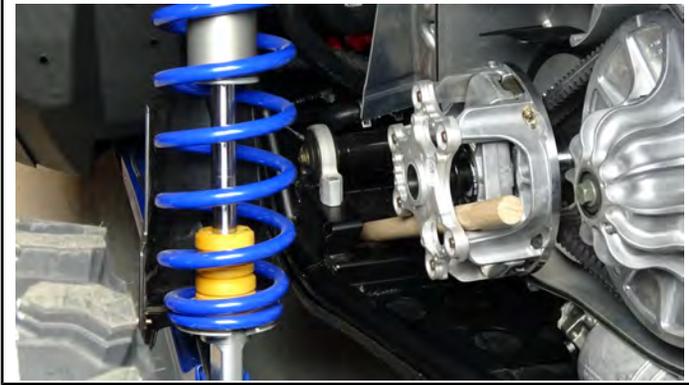
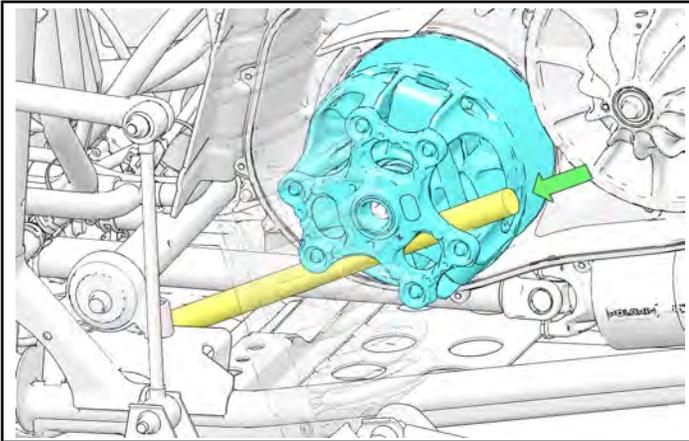
Dowel Use: using a 1" diameter by 18" long hardwood dowel insert the dowel through the primary clutch allowing it to rest against the chassis underneath the front engine cross member as shown.

The dowel must NOT touch the machined tower surface of the primary clutch, damage to the primary clutch may result.

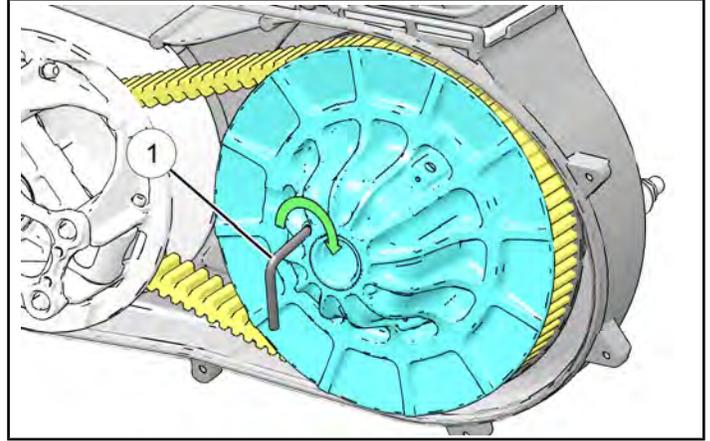
Clutch Spreader Tool:
2883577

5. With the clutch spreader tool ① installed, loop the belt over the primary clutch and over the driven clutch. Verify correct belt orientation.

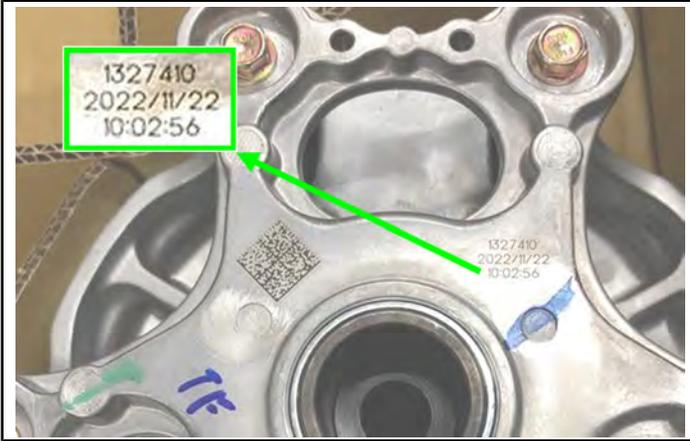
Record the manufacturing information numbers on the *NEW* primary clutch for warranty claims processing. Claims filing will not be permitted without the *NEW* primary clutch manufacturing information numbers.

Clutch Part Number: _____
 Clutch Production Date: _____
 Clutch Production Time: _____

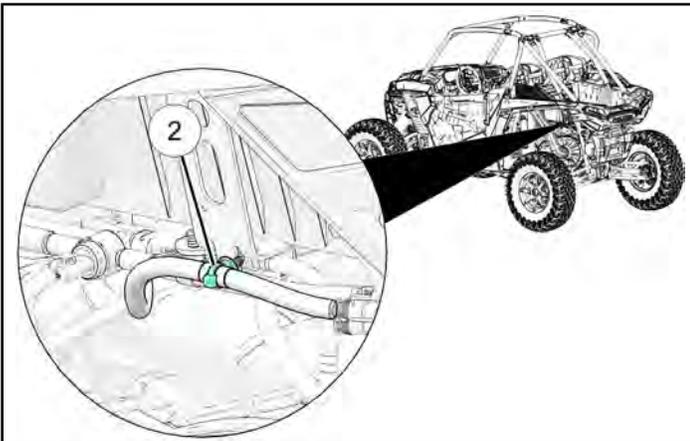
If the fir tree clip is damaged during removal, a replacement clip is provided in the kit.

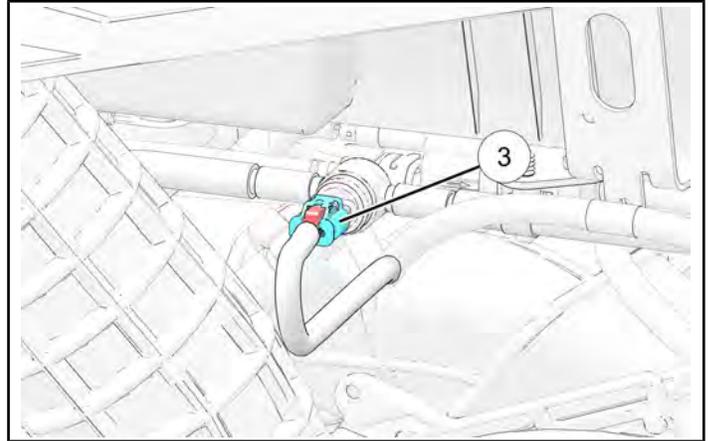
11. Release the secondary retaining clip ③ on the fuel pressure sensor using a screwdriver or pick. Push down on the connector tab to release the connector.

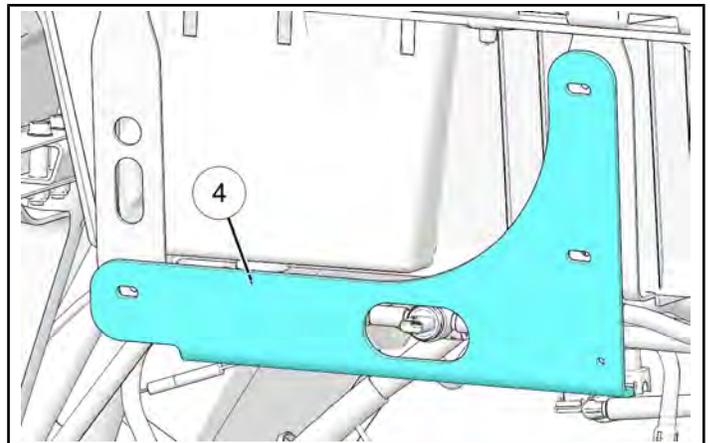
12. Set the fuel line bracket ④ into place.

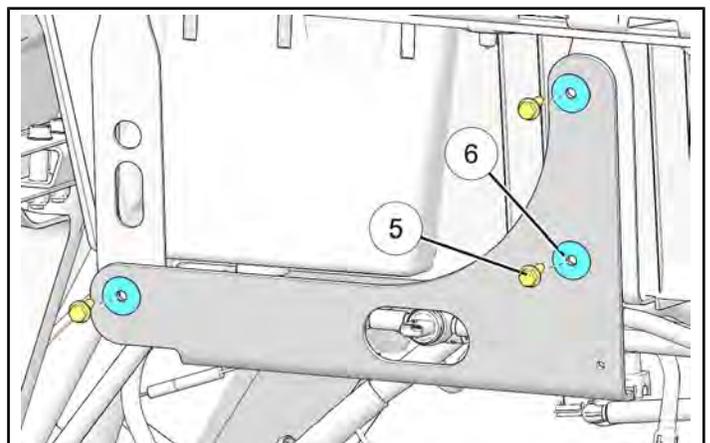
13. Loosely install the three fasteners ⑤ and washers ⑥ into the box support, two in the rear box support and one in the front box support.

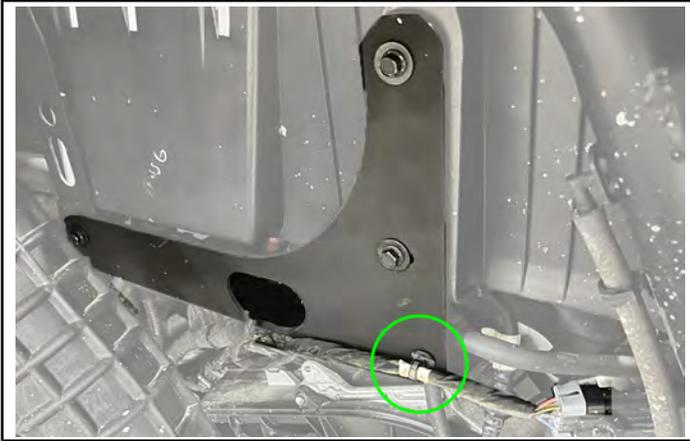
15. Attach the box harness to the fuel line bracket. If the fir tree clip has been damaged, a replacement is provided in the kit.

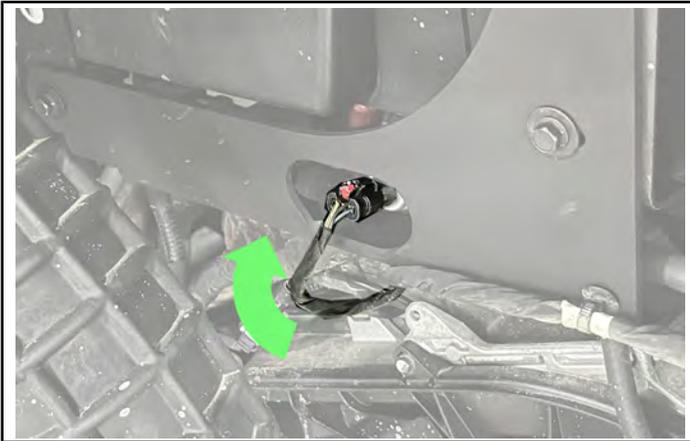
16. Route the fuel pressure sensor harness underneath and back through the hole in the bracket. Connect it to the sensor until a click is heard, and engage the red secondary retaining tab by pushing it towards the sensor.

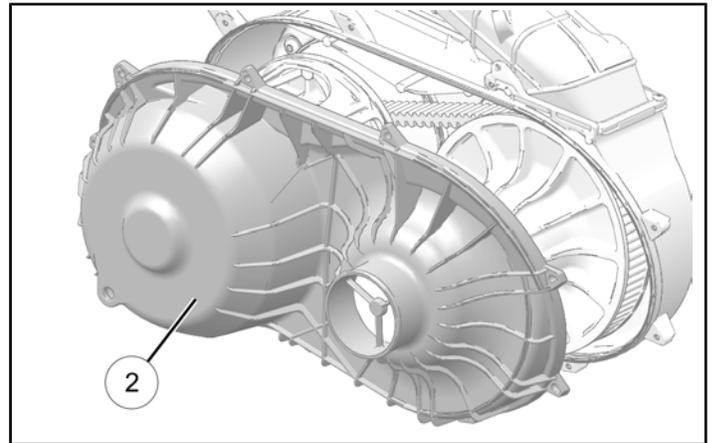
17. Install the outer PVT cover ②.

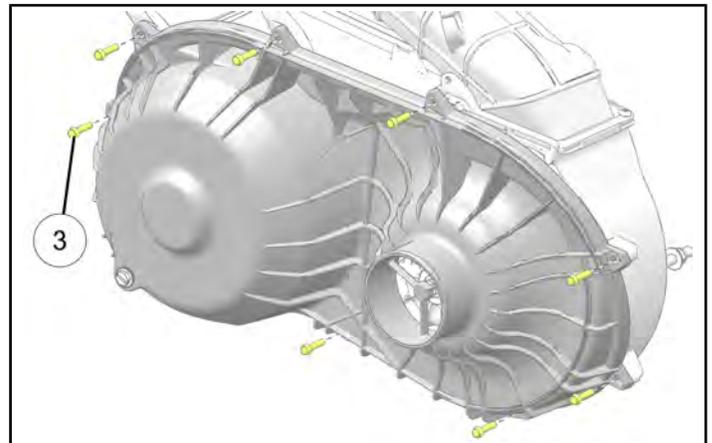
18. Install the outer cover fasteners ③. Torque to specification.

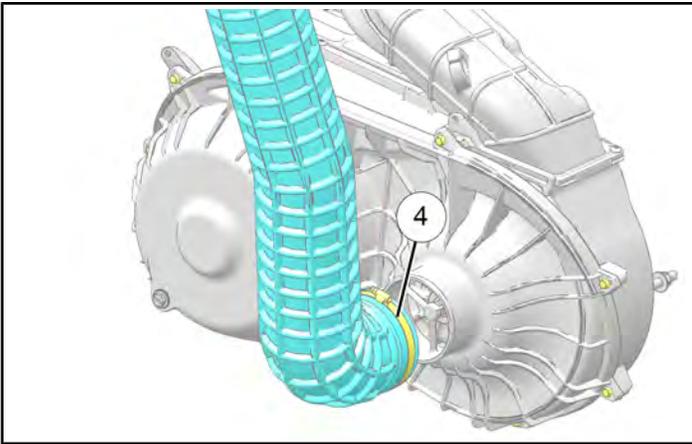
19. Install the PVT inlet duct to the outer clutch cover.
Torque the clamp ④ retaining the duct to the cover.

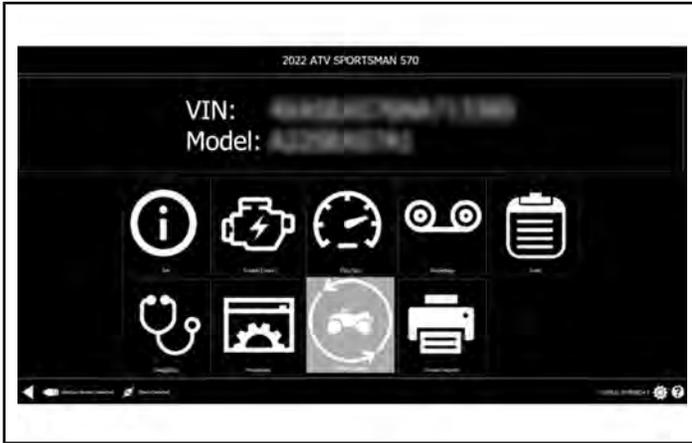
1. Connect the vehicle to Digital Wrench. Refer to the Digital Wrench II User Manual for information on connecting Digital Wrench II. Go to DEX > Service and Warranty > STOP Site > Other Publications > DWII User Manual.
2. Click the **Vehicle Update** button.

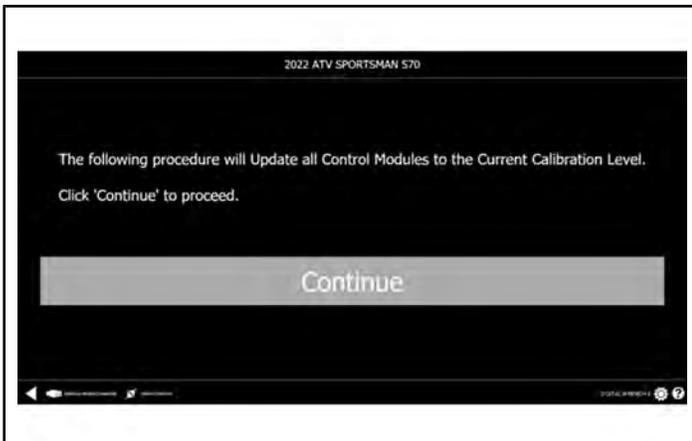
3. Click the **Continue** button. Digital Wrench will gather data from the vehicle modules.

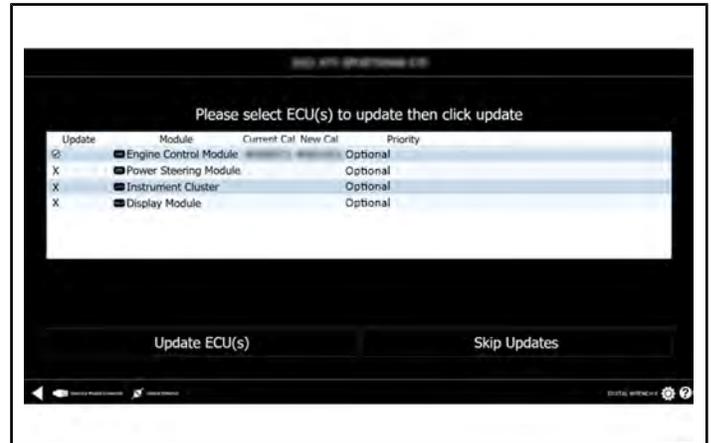
4. Select the Engine Control Module and any other modules with an update available, and click **Update ECU(s)**.
