SAFETY RECALL

Communication #: A-22-04

VERSION: R03 (December 7, 2022)

SUBJECT: STATOR WIRE ROUTING

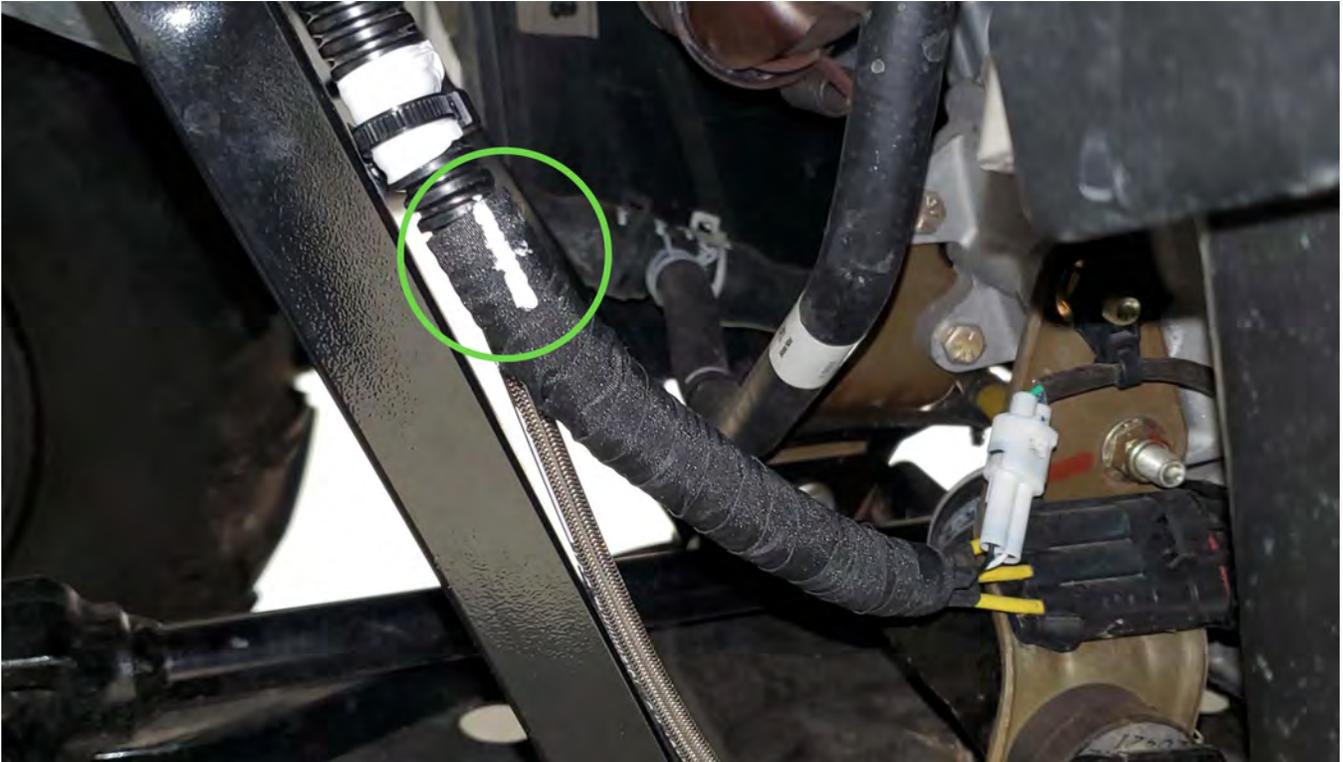
- Tape application starts 1/2" below the white tape.
- The tape is overlapping each wrap about 50%, until reaching the bottom opening of the conduit.
- A paint pen mark at the start of the tape.

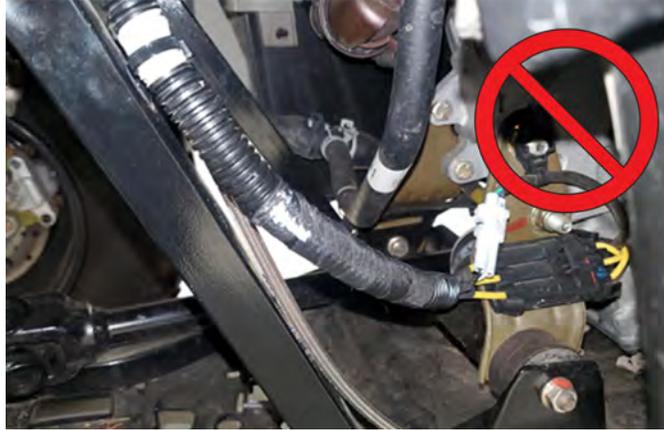
FAIL

- This photo fails because tape starts too far below the white tape and zip tie.

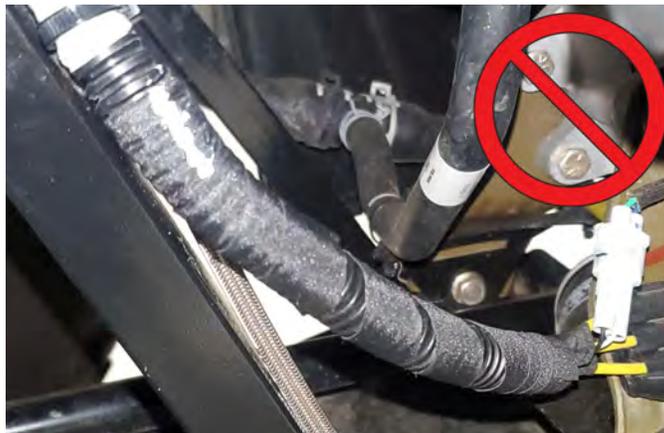
FAIL

- This photo fails because the tape has gaps that show it is not properly overlapped.

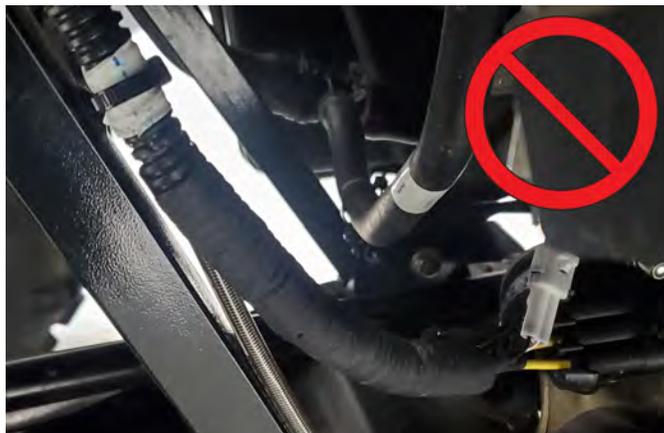
FAIL

- This photo fails because there is no paint pen mark at the start of the tape.

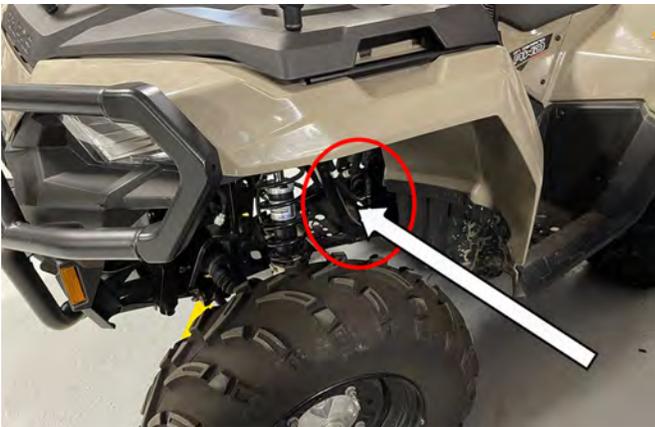
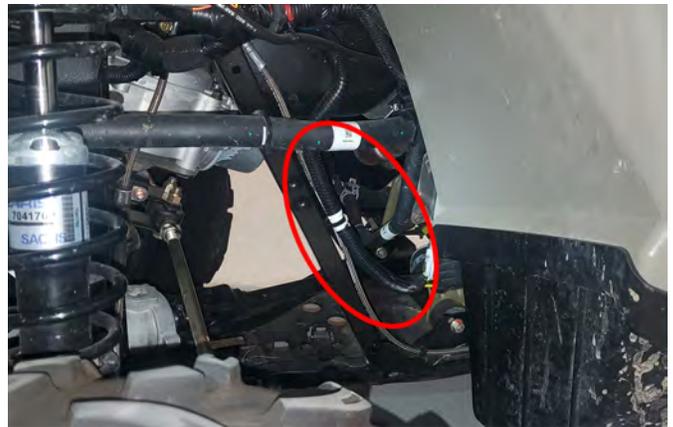
1. Park vehicle on a flat surface.
2. Shift vehicle into PARK.
3. Push engine stop switch to OFF position.
4. Turn key to OFF position and remove key.
5. Locate stator wires in the front-left wheel well as shown.

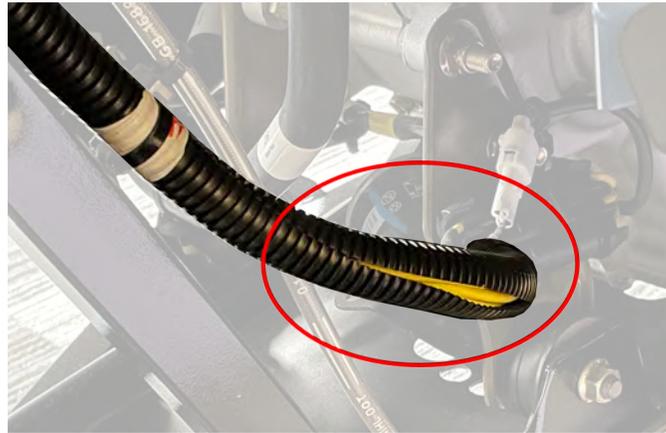
- Inspect the conduit to see if any yellow and/or black wires are not contained in the conduit.

If wires are visible but are contained in the conduit, it **PASSES** inspection.

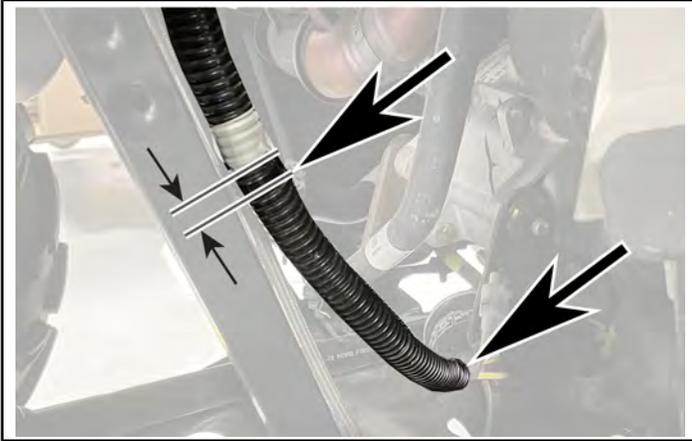
1. Make sure all the wires are contained in the conduit.
2. Using mild soap, water, and a clean rag to clean the conduit surface from 1/2" (12.7 mm) below the white tape to the end of the conduit.

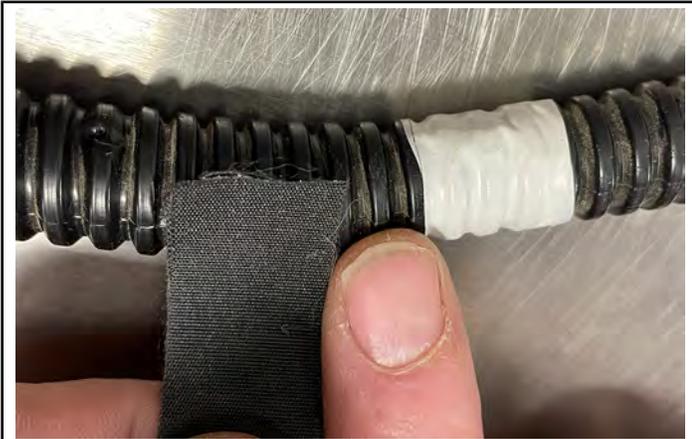
3. Using the tape supplied, start wrapping the conduit a finger width (1/2") below the white tape.

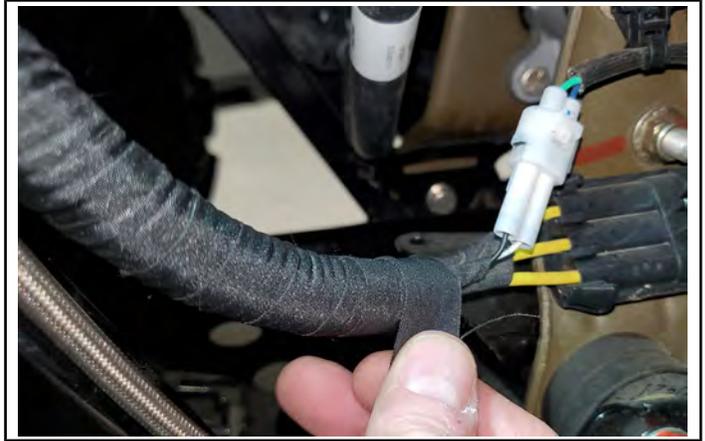
4. Wrap the tape, overlapping each wrap about 50%, until you reach the bottom opening of the conduit.

DO NOT wrap tape around the bottom of the conduit.

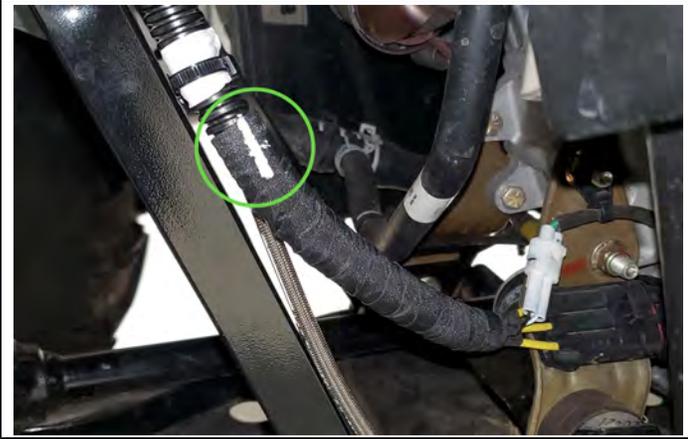
- Using a paint marker, make a clearly visible paint marking on the tape from the top edge down at least one inch in length.

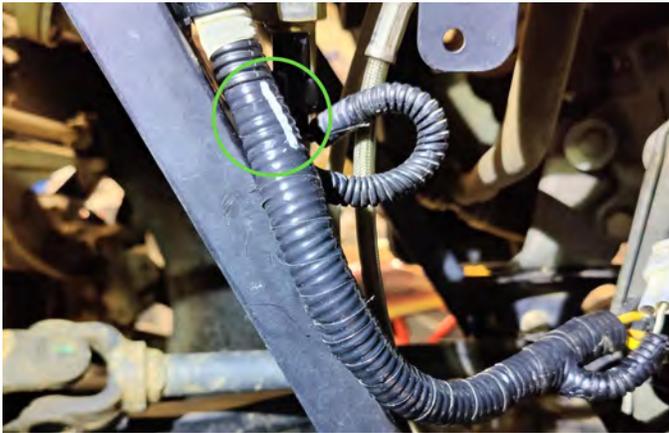
2021

International models may have different conduit breakouts depending on the model year.

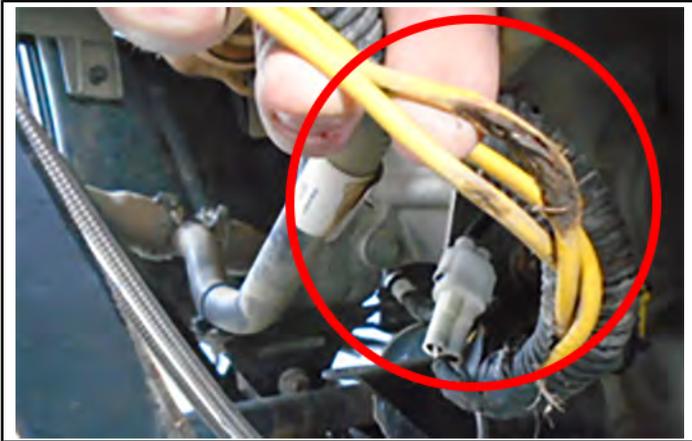
1. Inspect the wires not contained in the conduit for signs of exposed burns or abrasion to the wire insulation or signs of exposed bare wires.

2. If no damage is found, route the wires inside the conduit and proceed to **TAPE APPLICATION** section below.
3. If damage is found, start an Ask Polaris case as directed on **page 7** for A-22-04-B for further instructions.

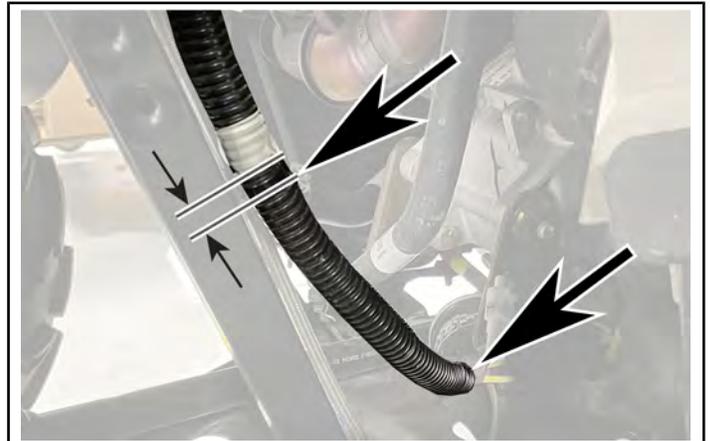
1. Make sure all the wires are contained in the conduit.
2. Using water, mild soap, and a clean rag, clean the conduit surface from 1/2" below the white tape to the end of the conduit.

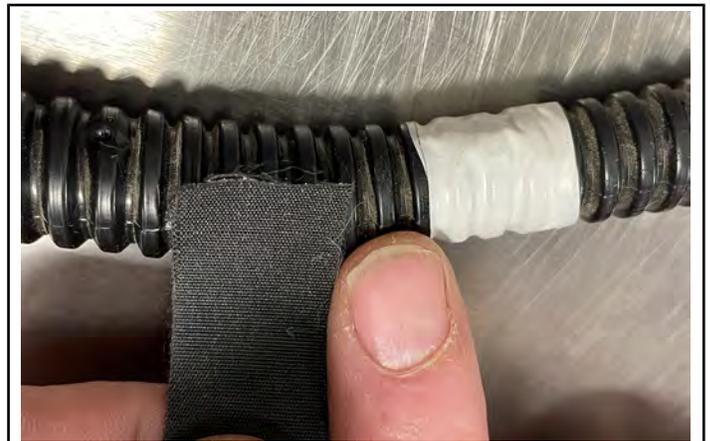
3. Using the tape supplied, start wrapping the conduit a finger width (1/2") below the white tape.

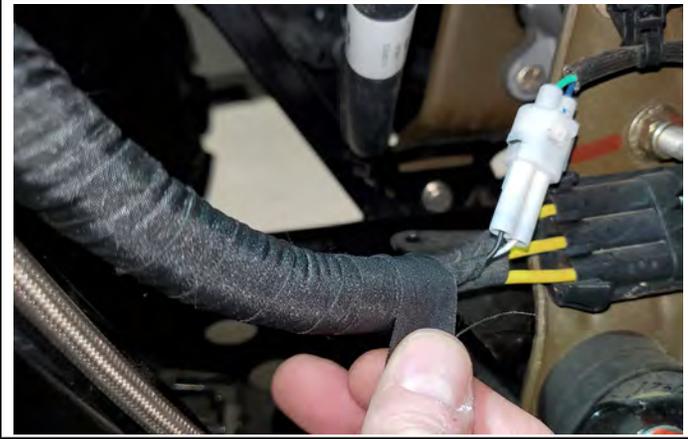
4. Wrap the tape, overlapping each wrap about 50%, until you reach the bottom opening of the conduit.

DO NOT wrap tape around the bottom of the conduit.

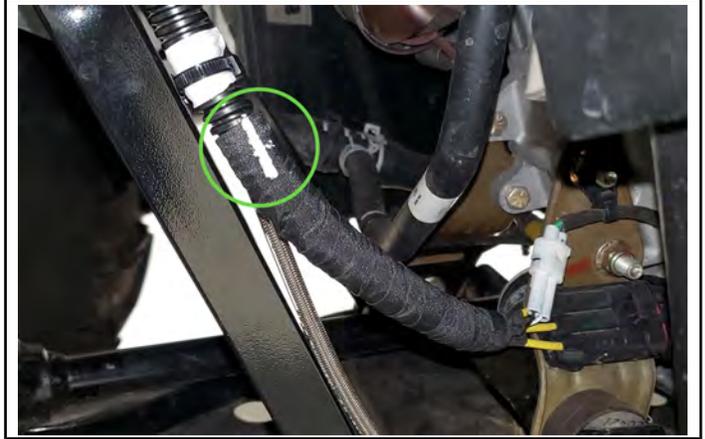
6. Using a paint marker, make a clearly visible paint marking on the tape from the top edge down at least one inch in length.

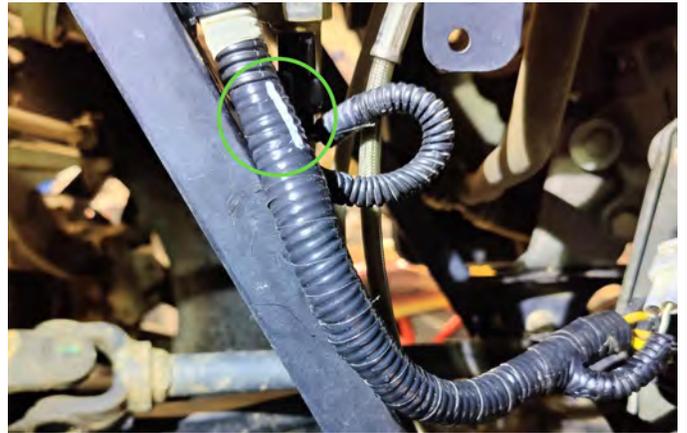
2021

International models may have different conduit breakouts depending on the model year.
