SAFETY RECALL

Communication #: S-22-09-A

SUBJECT: SNOWMOBILE FUEL TANK PURPOSE

Polaris has determined that with degraded fuel, and especially after extended storage, some snowmobiles may pose a risk of fire due to electrostatic discharge (ESD) inside the fuel tank. Under specific conditions, vapors may be ignited inside the fuel tank, posing a potential injury hazard.

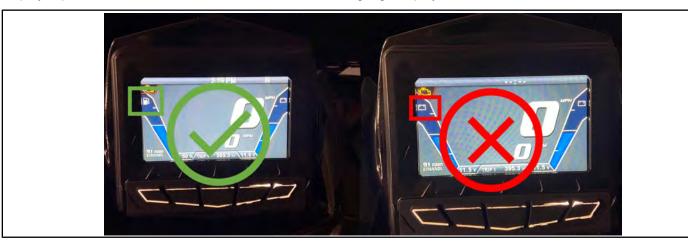
The PIDD will not show a fuel level indicator if the wiper arm was not correctly installed. Note that other system gauges may display in place of the fuel level indicator. Make sure that the gauge displayed is a fuel level indicator.
